Hammering Wear Impact Fatigue Hypothesis WEC/irWEA failure mode on roller bearings

Presented by Johan Luyckx
Manager Product Integrity Management
Hansen Transmissions International nv
Kontich Belgium

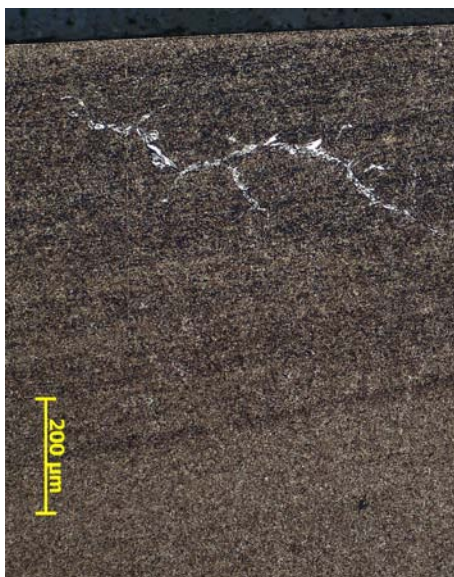
Case carburised bearing steel : WEC/irWEA failed bearings

Subsurface networks with cracks and white etching area's

Small network

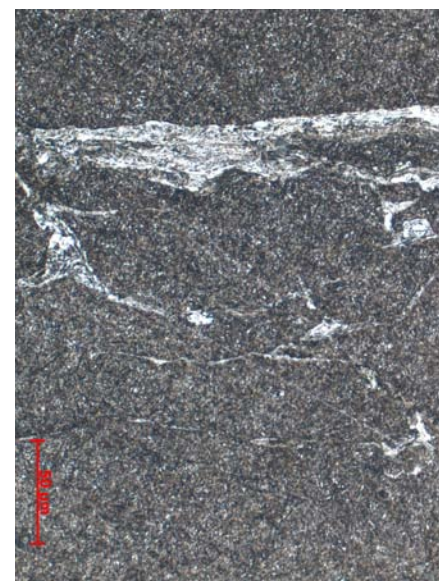
Large network

Close-up view

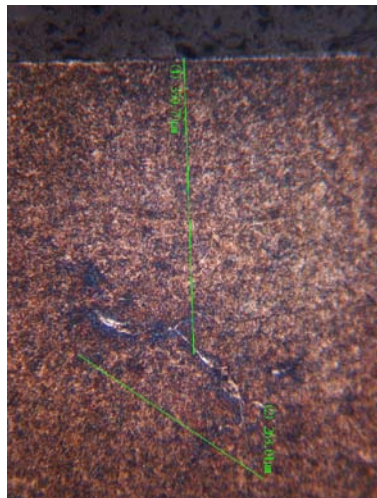
Bainitic bearing steel : WEC/irWEA failed bearings

Subsurface
networks
with cracks
and white
etching
area's

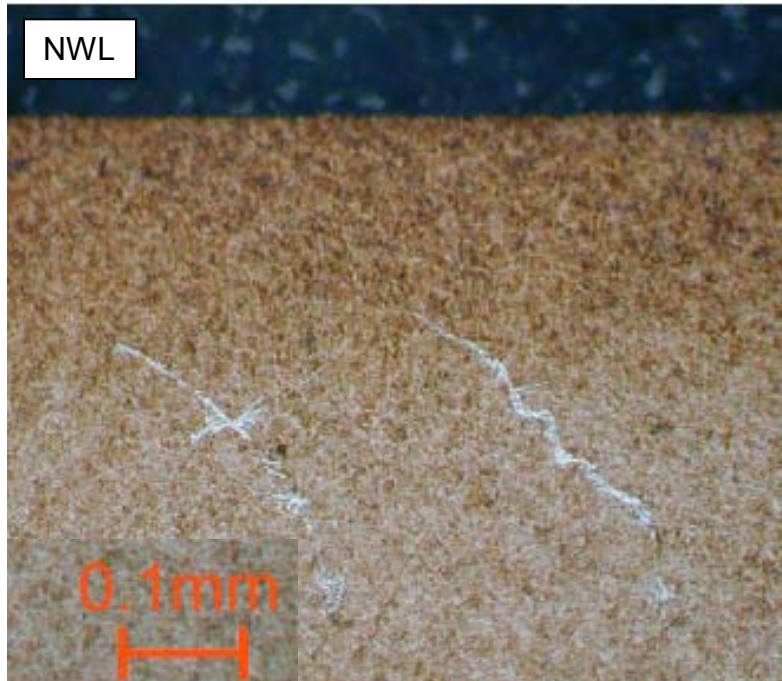
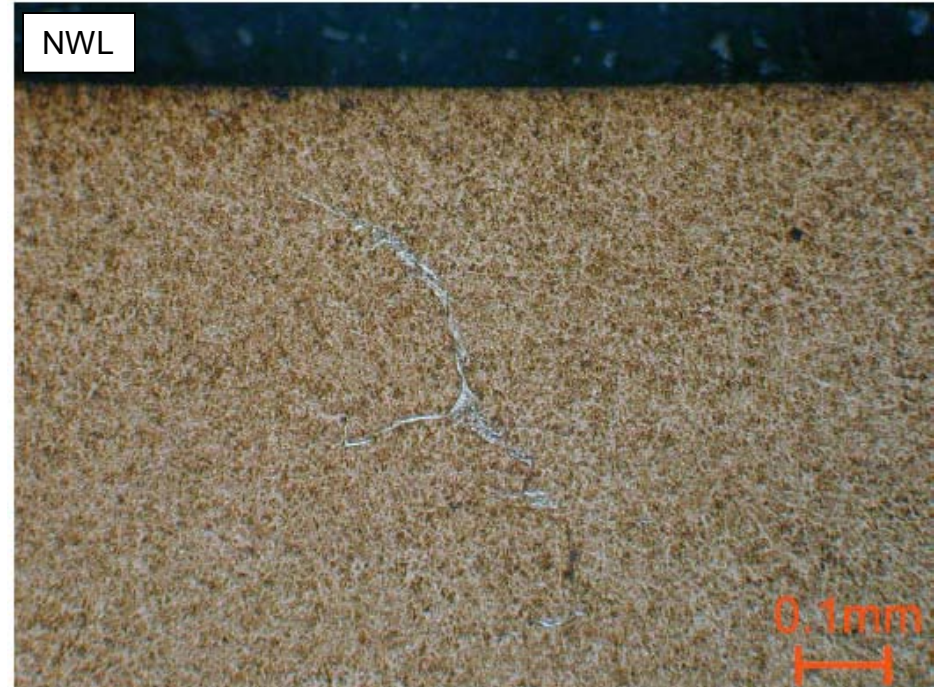
Martensitic bearing steel : WEC/irWEA failed bearings

Isolated small subsurface damage with white etching area's

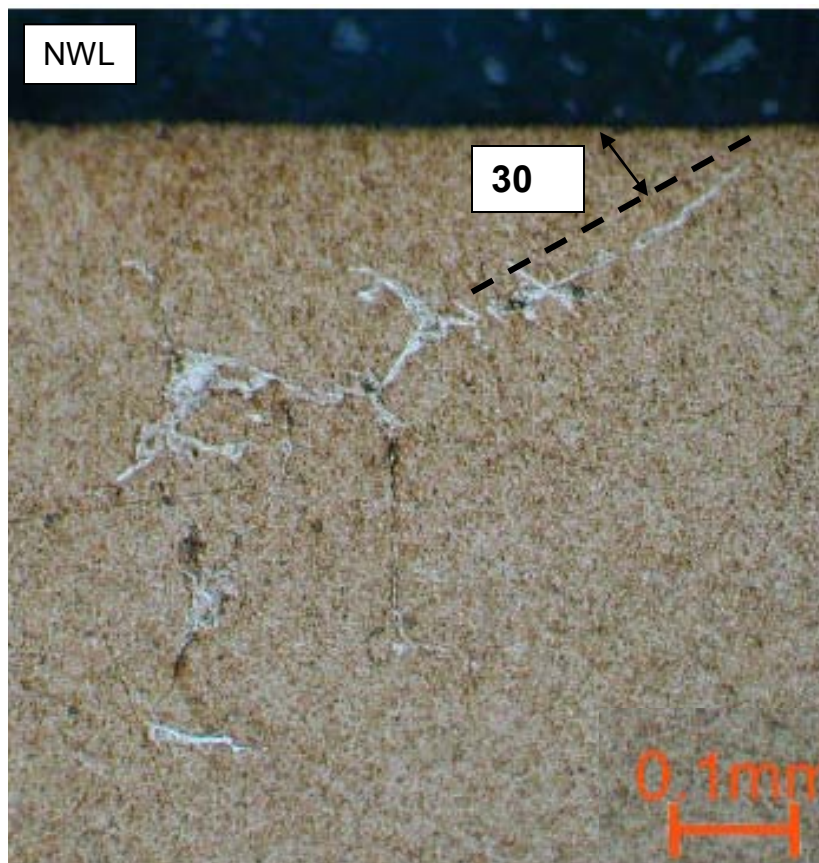
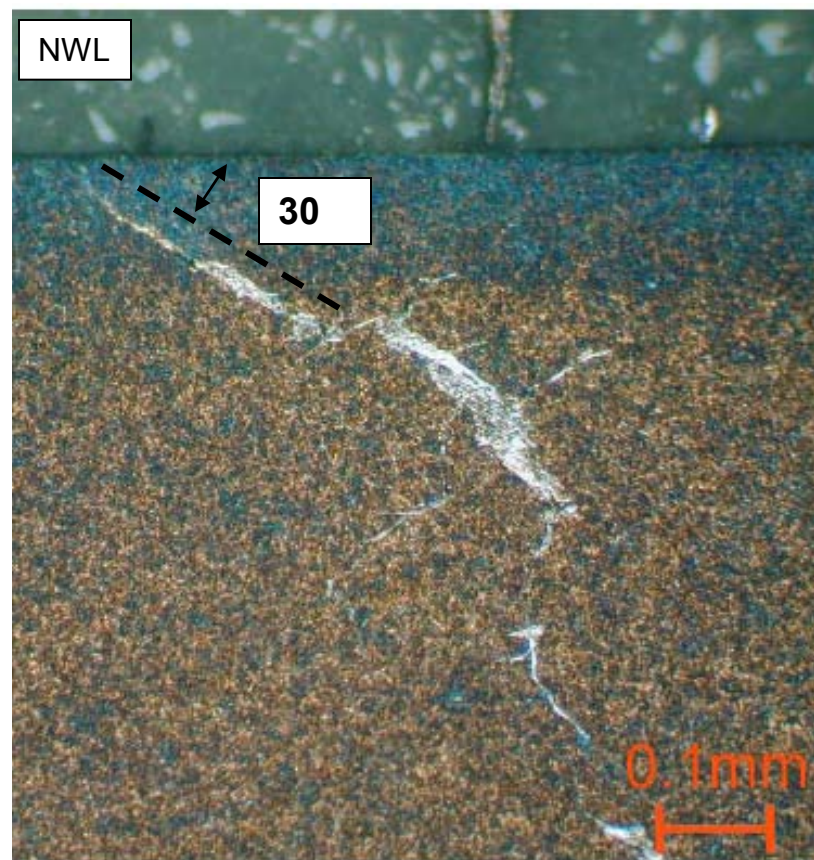
Martensitic bearing steel : WEC/irWEA failed bearings

Subsurface damage with 30° oriented crack towards the raceway and white etching development

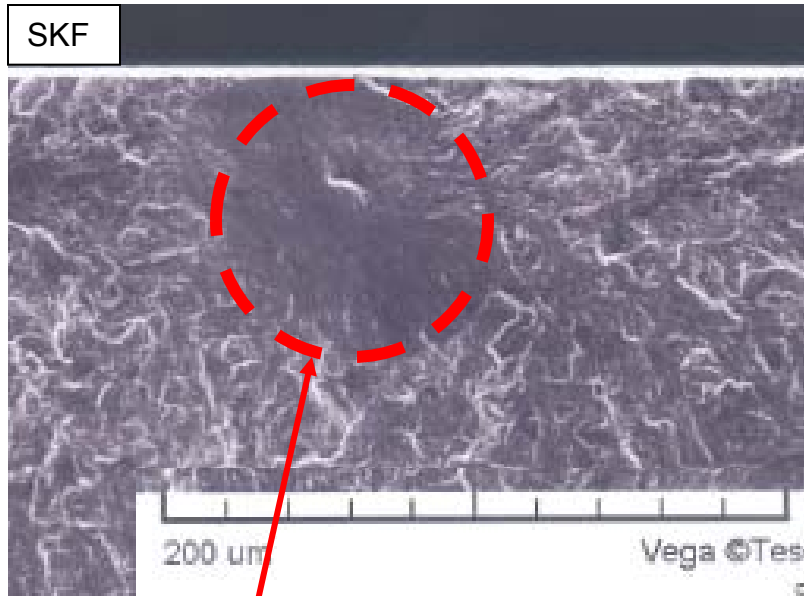
Circular crack around an inclusion/butterfly

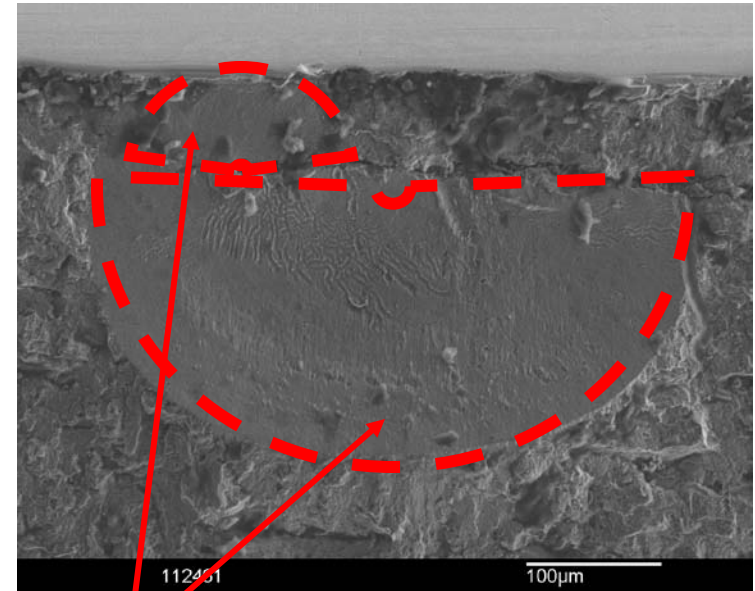
Semi circular cracks around an inclusion

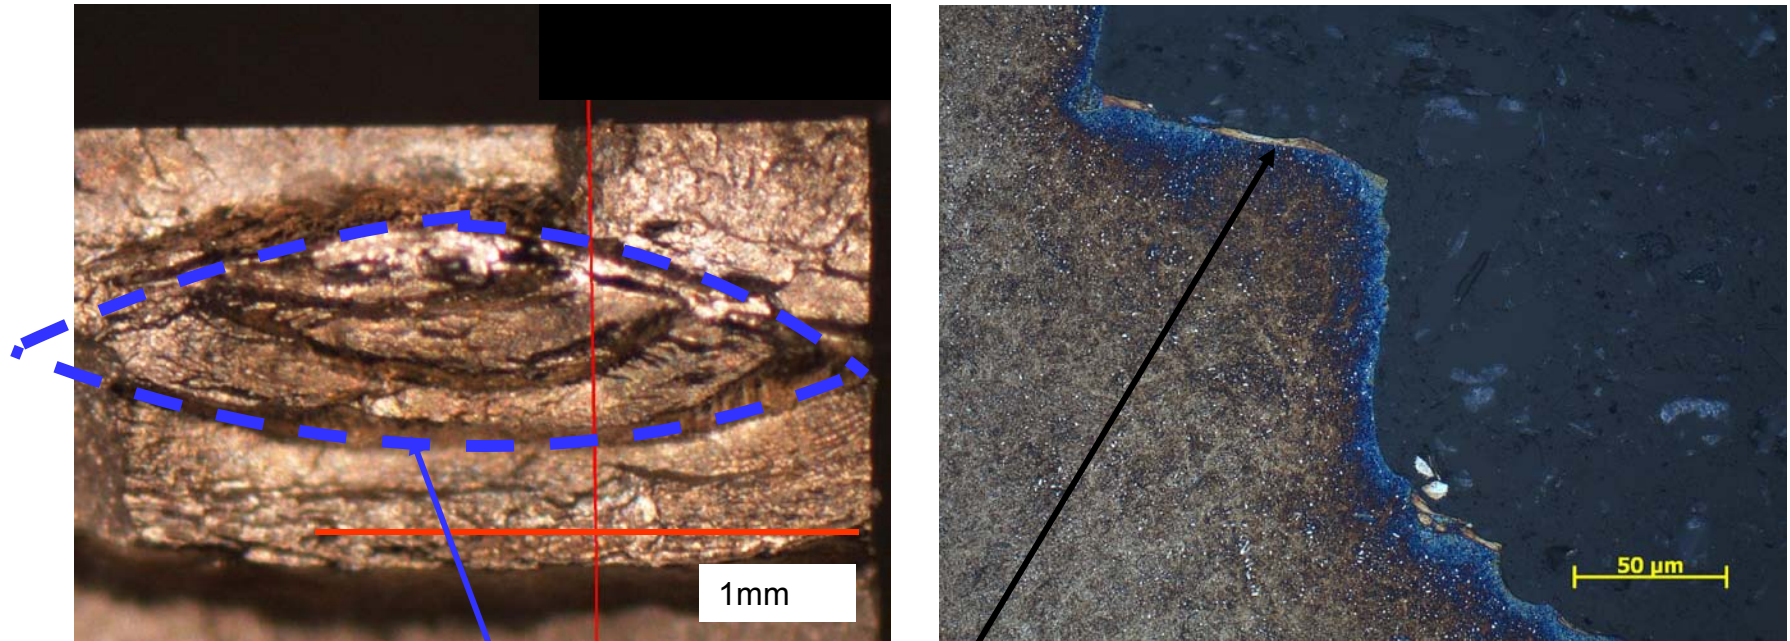
V-segment with white etching material
area's in parallel part of the crack

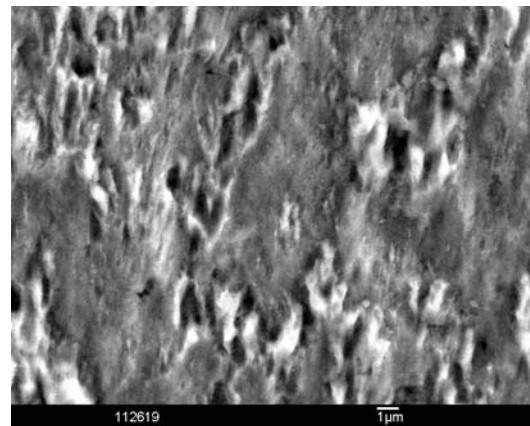
Flat crack surface with **voids**
surrounded by elevated borders

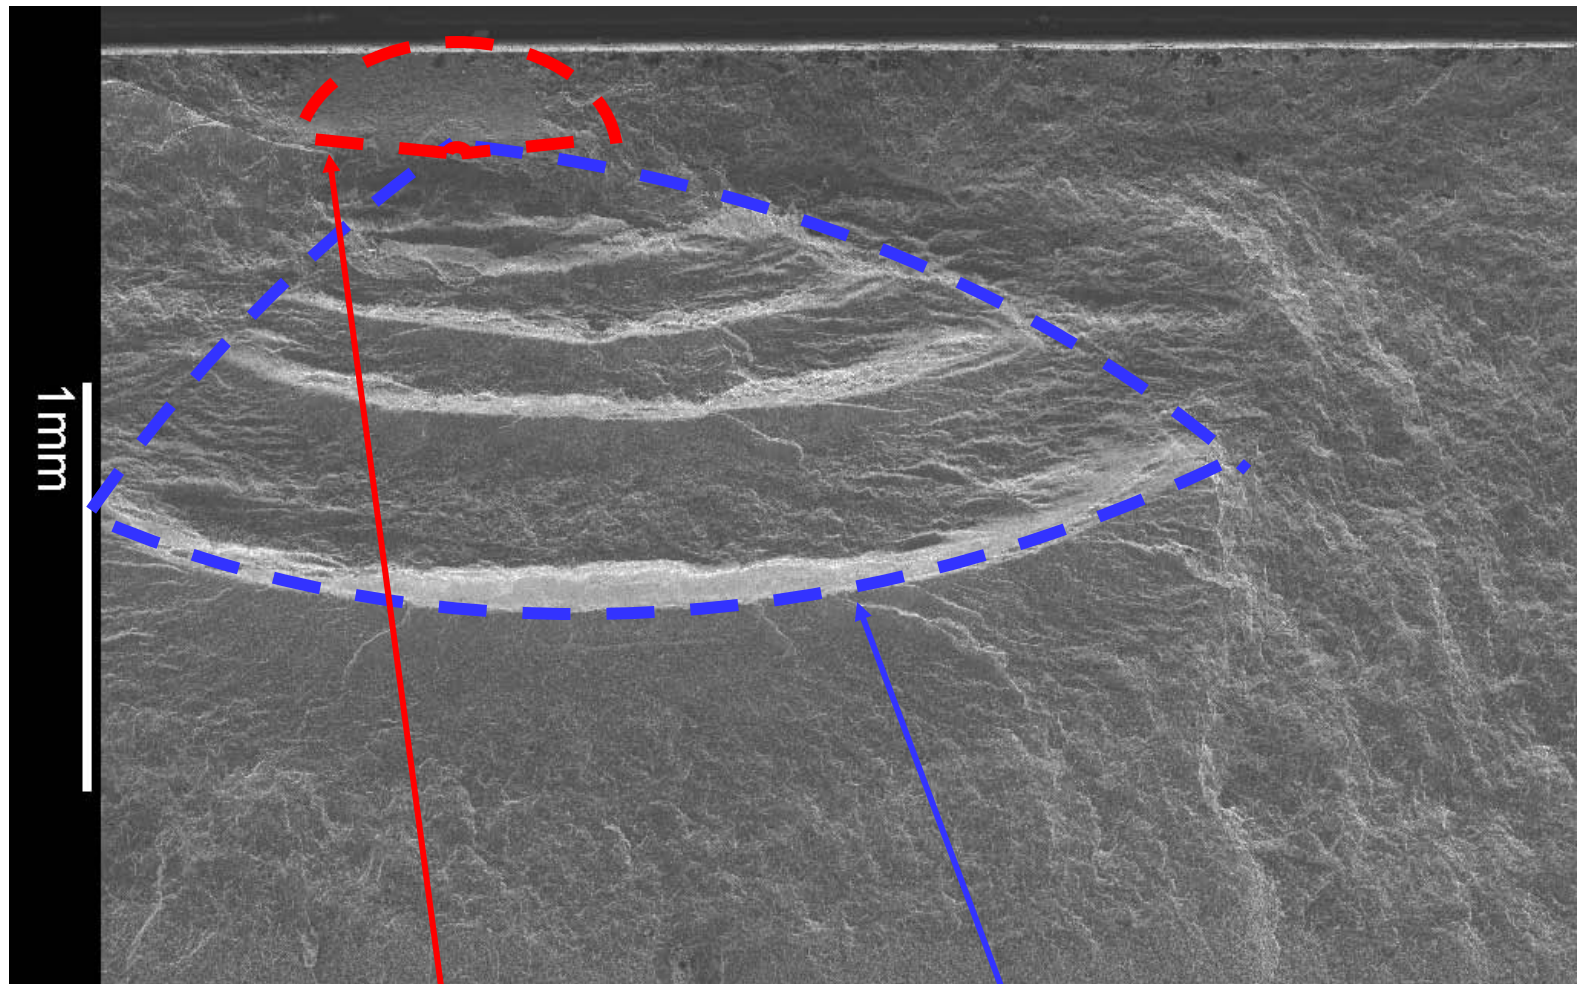
Semi circular crack and large V-segment

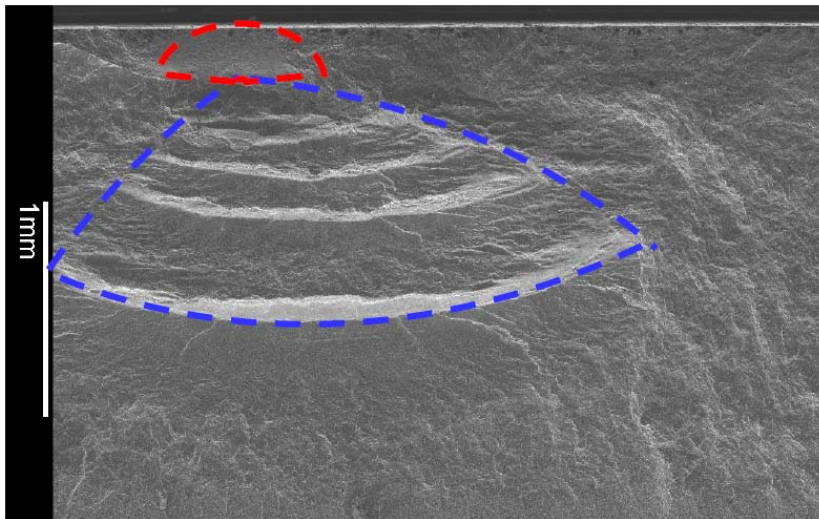
Perpendicular
cutting (before
crack opening)
and later
microstructure
etching

Semi circular crack and large
V-segment with **white etching**
material area's in parallel parts
of the crack

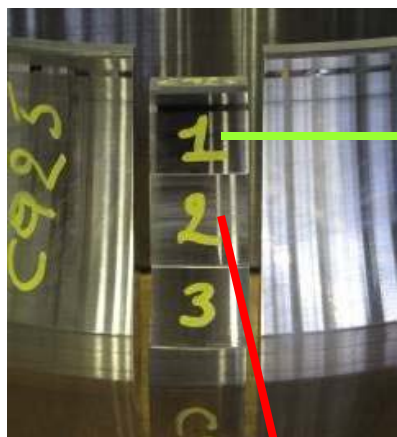
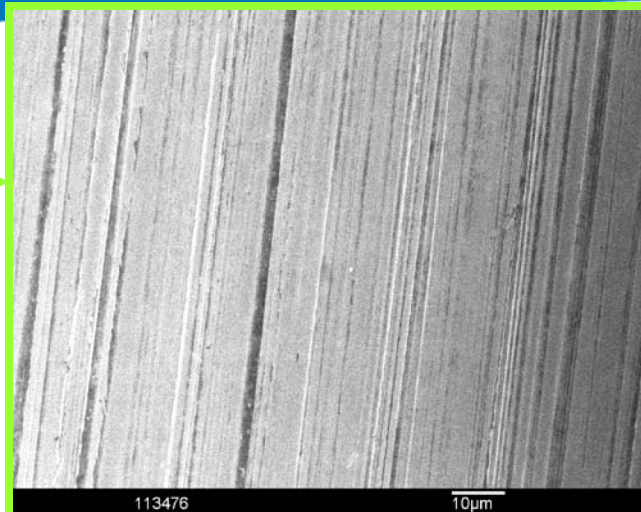
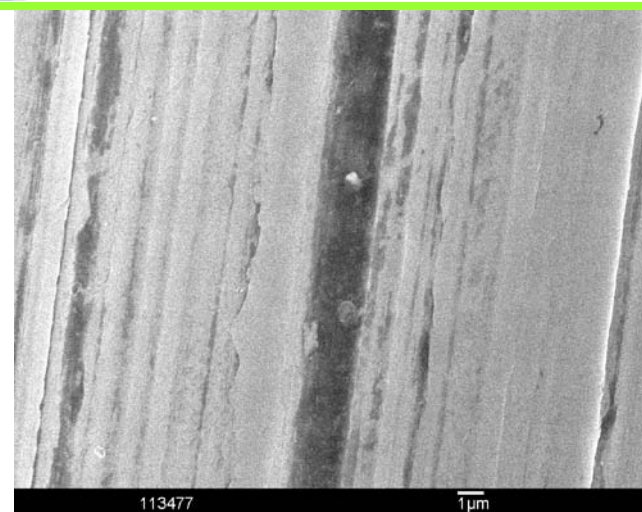
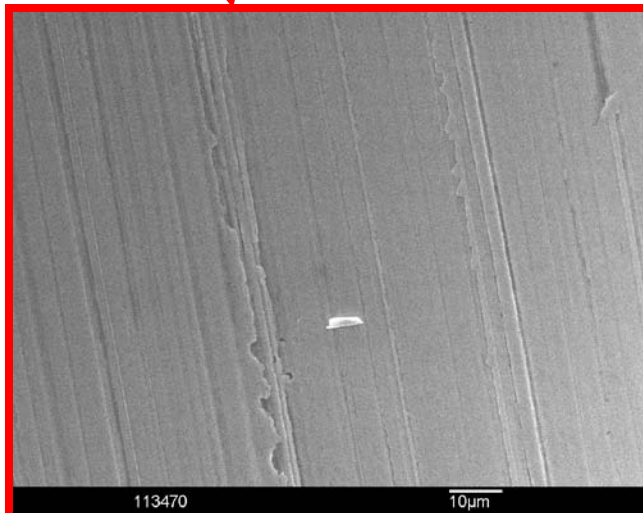
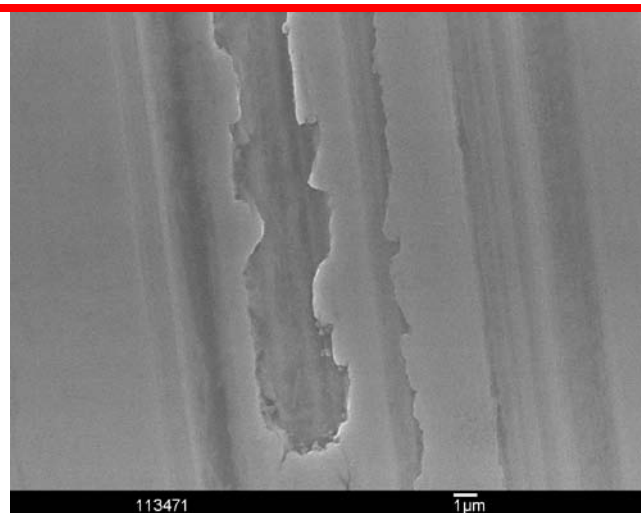
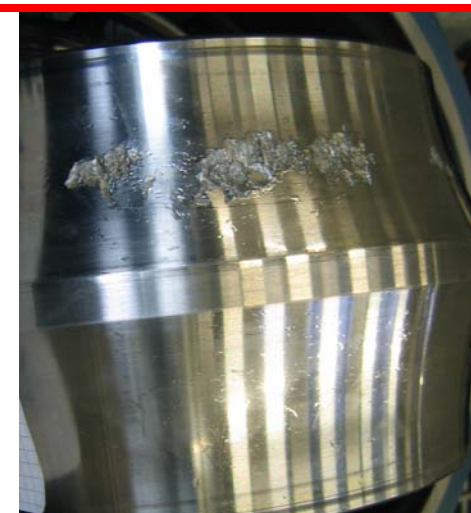
Raceway of inner ring SRB of WEC/irWEA critical bearing application (not failed). More intense hammering wear on sample 2 from middle of raceway where spalling is initiated in case of WEC/irWEA bearing failure.

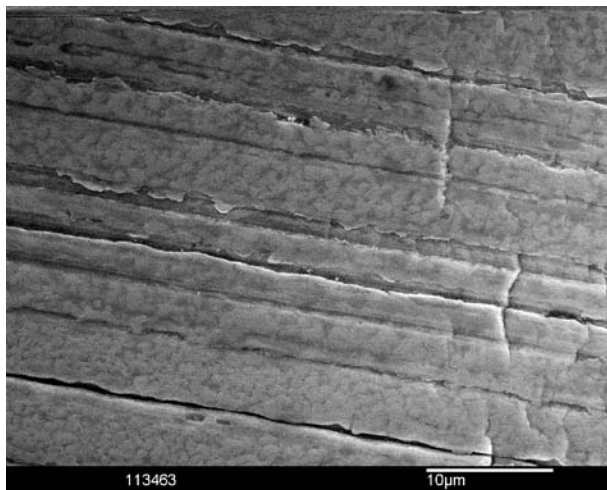
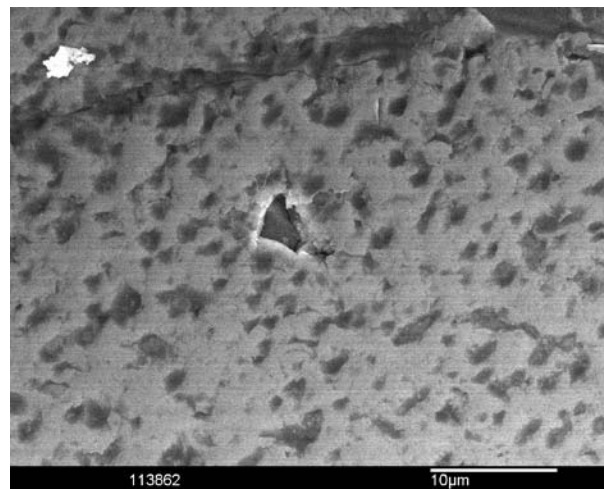
Raceway
martensite
bearing
supplier

Raceway
case
carburised
bearing
supplier

Raceway
case
carburised
Hansen

Comparison between raceways. Lower picture is Hansen case carburised without hammering wear. No WEC/irWEA failures on Hansen case carburised raceways.

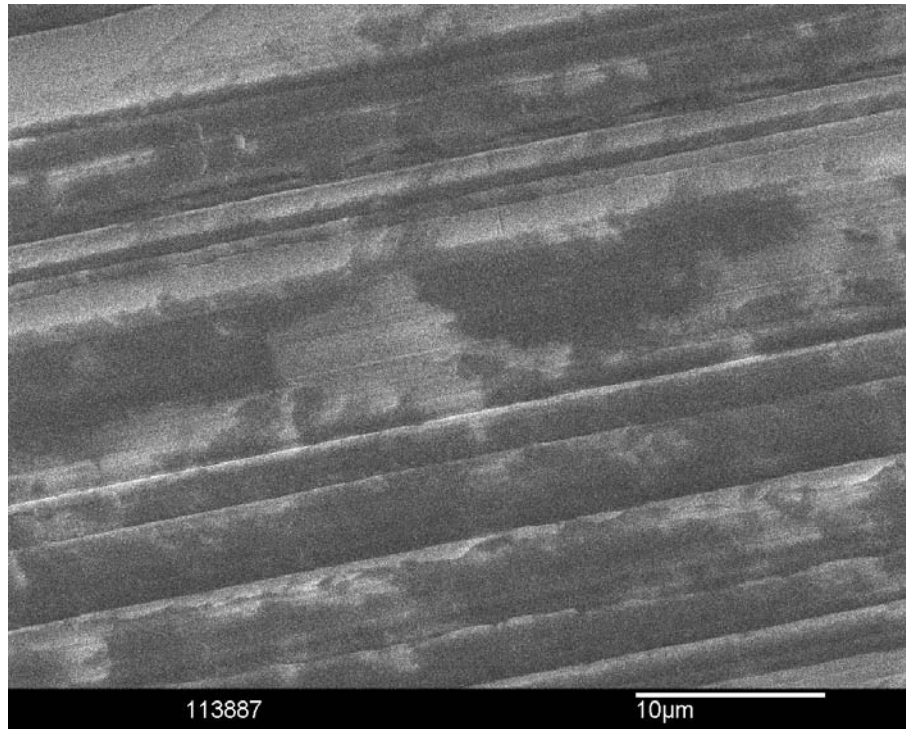
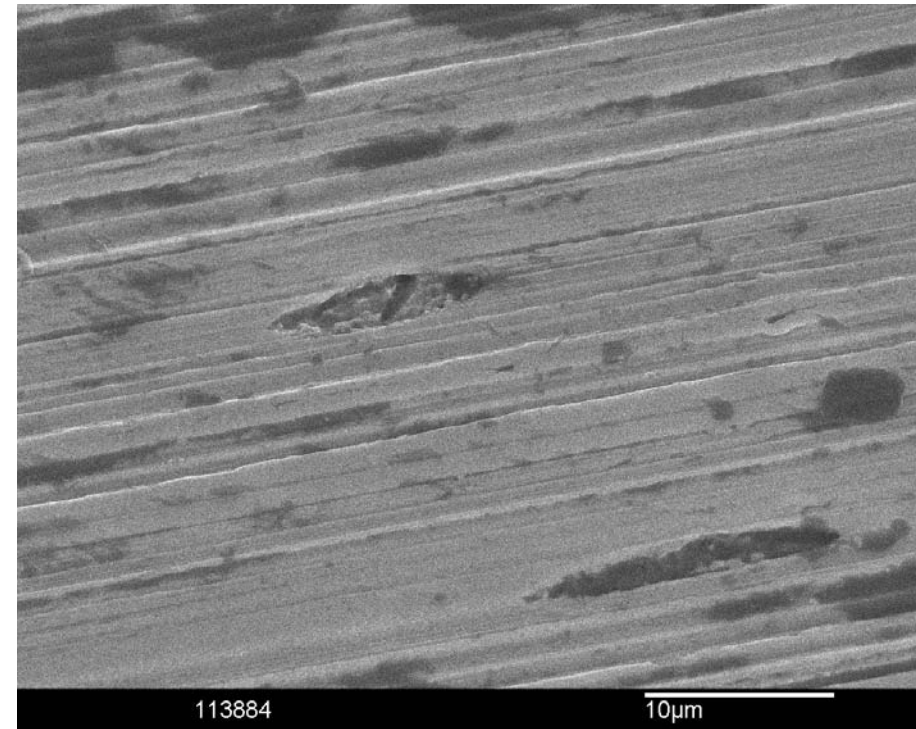
Hansen high speed gear tooth with limited (left) and more (right) wear development. Gear flank topography has minor hammering wear of asperities tops. No WEC/irWEA gear failures observed on Hansen gears.
